Transport Accident
Investigation
Commission

Final report

Maritime inquiry MO-2023-203
Container vessel, Shiling
Loss of control
Wellington harbour
15 April 2023

June 2025

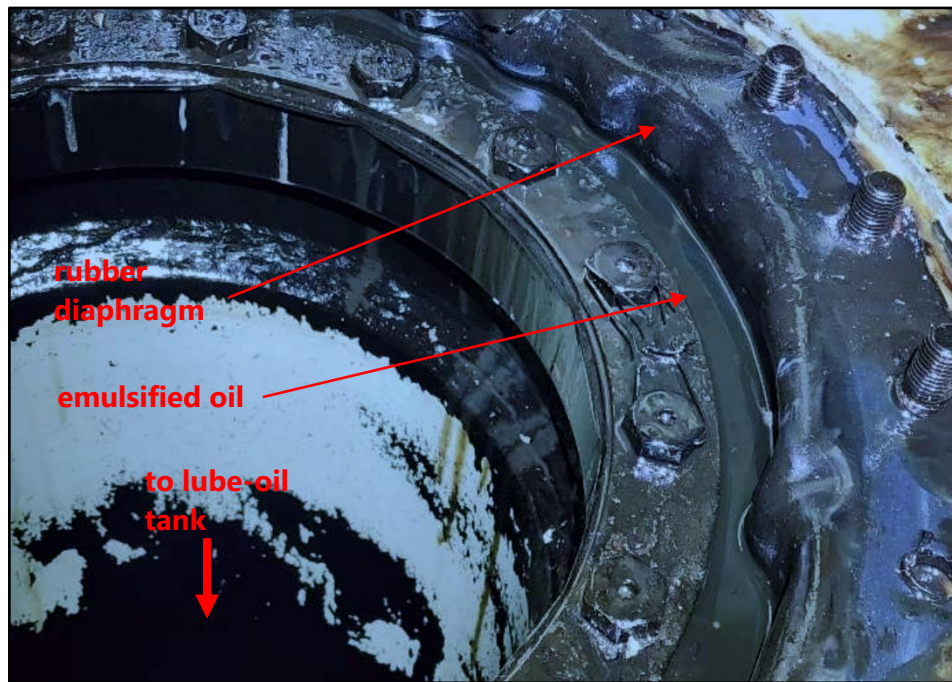
- 2.67. When the *Shiling* arrived in Wellington, Asian-Alliance requested that a technician from Wärtsilä Korea attend the vessel. The Commission's investigators also attended. On first inspection it was noted that the engine-room bilge located near the main-engine flywheel was full and water from this bilge was still lapping over the void under the main-engine sump.
- 2.68. The main engine crankcase was opened to enable access to the three drain ports in the engine sump and to the rubber diaphragms fitted between these drain ports and the lube-oil tank below. It was observed that water had entered the lube-oil sump tank via the rubber diaphragms. The oil residue captured within the fold of the damaged diaphragm had emulsified where the water had entered and run down the steel pipe into the lube-oil tank (see Figure 6).

Figure 6: Engine sump showing rubber diaphragm fitted to drain port during dismantling

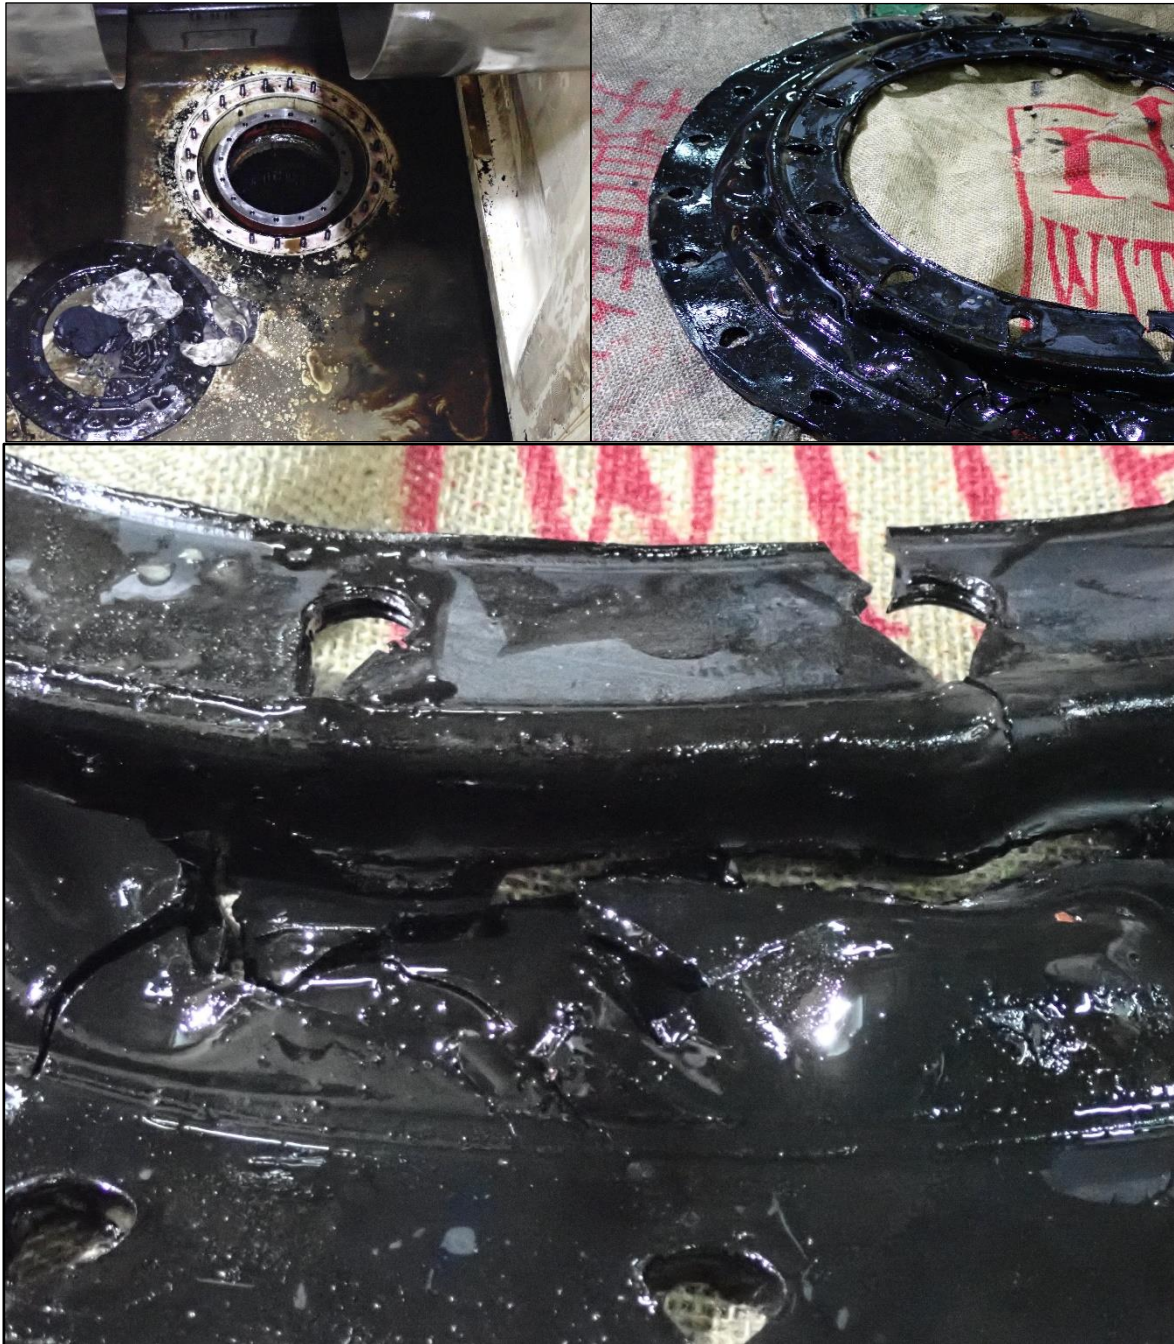
- 2.69. All three rubber diaphragms were removed from the drain ports. All were observed to be damaged (see Figure 7). The three diaphragms were sent to Quest Integrity⁴³ for examination and testing together with a representative new sample diaphragm supplied by Asian-Alliance.

Figure 7: One of three rubber diaphragms removed from main engine sump.

The failed diaphragms removed from service had severely degraded, especially in the parts exposed to air and oil outside of the flange areas. A network of craze cracking was present on the lower side of the diaphragm exposed to air that was consistent with thermo-oxidation of nitrile rubber when exposed to trace concentrations of ozone and/or metallic ions in solution.

The degradation was severe enough to cause the areas exposed to air and oil to fracture during handling and preparation of tensile test samples, limiting the testing able to be performed.

It is considered likely that the failed samples were in service beyond the service time recommended by the engine manufacturer and that inspection within the recommended interval would have identified the visible degradation before the observed failures.

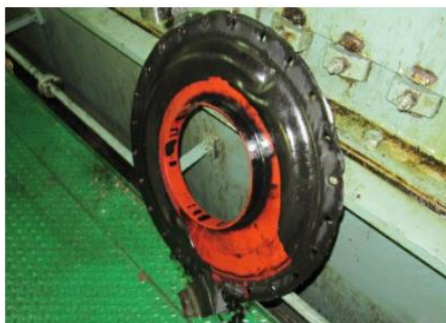
Failed diaphragm

- Inspect the diaphragm sealing in the crankcase oil outlet every 32,000 hours of operation, and replace the diaphragm if indicated by the inspection.

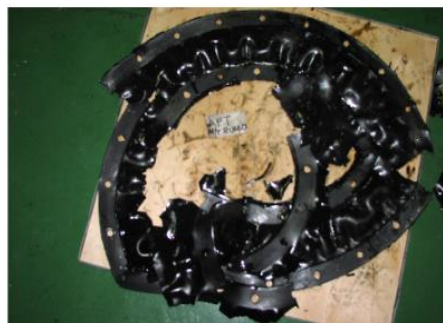
Deteriorated diaphragm
