Transport Accident
Investigation
Commission

Final report

Maritime inquiry MO-2023-203
Container vessel, Shiling
Loss of control
Wellington harbour
15 April 2023

June 2025

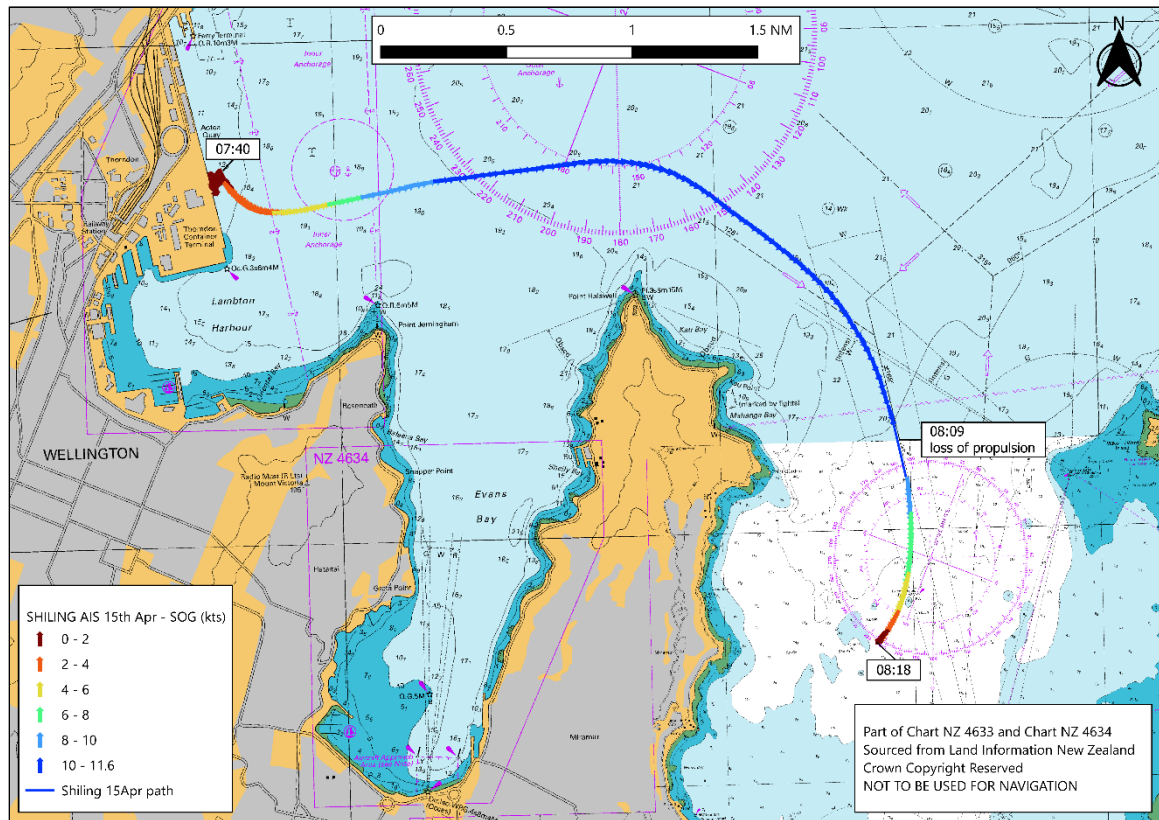
Figure 3: Wellington Harbour showing track of *Shiling* from its berth to Falcon Shoal at 08:18

- 2.23. The ship had been swinging to starboard towards Falcon Shoal when the main engine stopped. After a short delay, the pilot let go first the port and then the starboard anchor, which resulted in the ship stopping just before it was about to run aground inside the shoal.²² The pilot had delayed letting go the first anchor until the ship's bow was clear of the adjacent Falcon Shoal Beacon (see Figure 3).

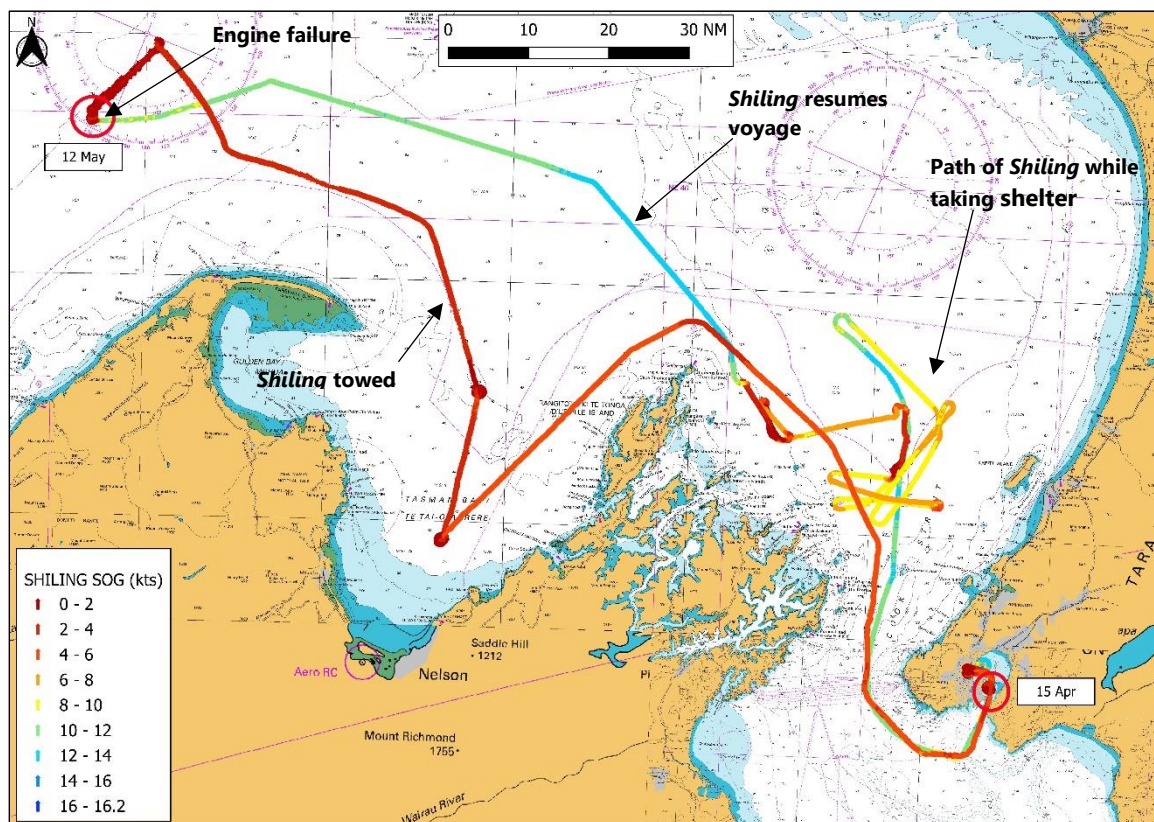
Figure 5: Path of *Shiling* after departing Wellington on 10 May 2023
(showing ship's speed over ground)

- 2.48. The *Skandi Emerald* established a tow by 1730 and began towing the *Shiling* towards the shelter offered in Golden Bay.
- 2.49. The *Shiling* was anchored in Golden Bay at about 1730 on 13 May 2023, and was eventually towed by the *Skandi Emerald* back to Wellington, arriving on 23 May 2023 (see Figure 5).

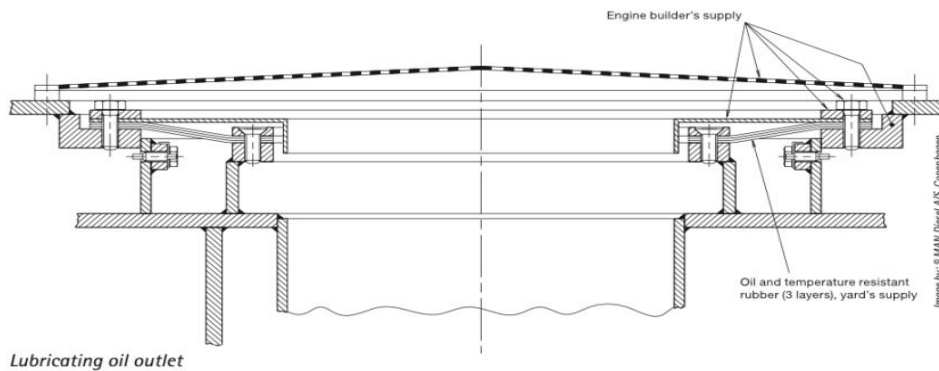
Deteriorated diaphragm

It should be stated that during construction of the ship, the parts in question are supplied by the yard, and not by the engine manufacturers.
